## "Full" Reserve Study

### Town Center Carbondale, CO

**Report #: 33035-0**  
**For Period Beginning: January 1, 2018**  
**Expires: December 31, 2018**

**Date Prepared: September 16, 2017**

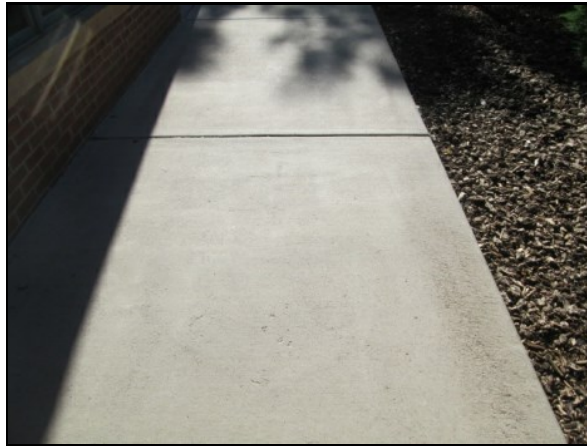
**Comp #: 2115 Concrete Walkways - Repair - 10%**

Useful Life:  
5 years

Remaining Life:  
3 years

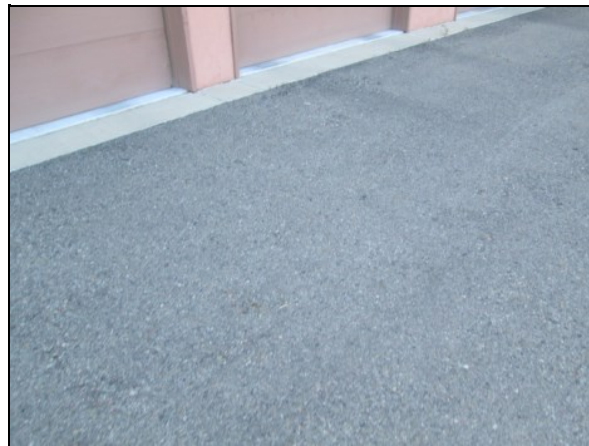
Useful Life:  
3 years

Remaining Life:  
0 years

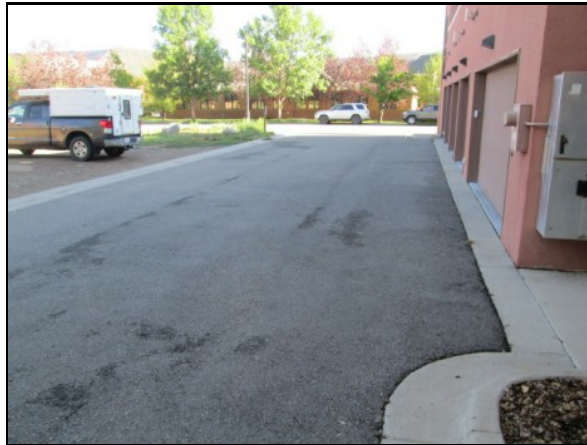
Useful Life:  
25 years

Remaining Life:  
12 years

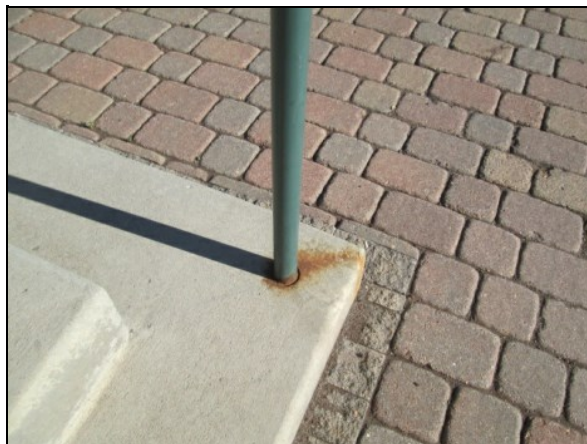
Useful Life:  
30 years

Remaining Life:  
17 years

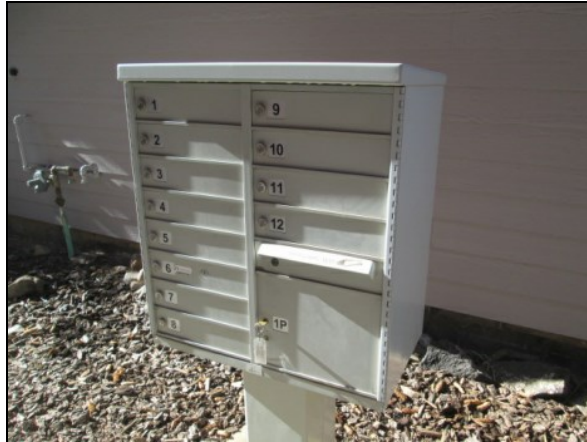
Useful Life:  
30 years

Remaining Life:  
17 years

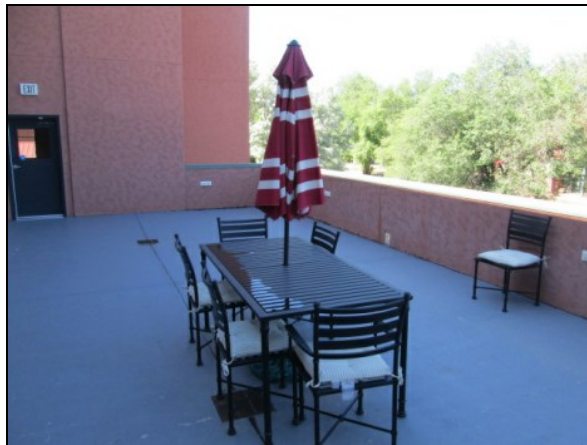
Useful Life:  
20 years

Remaining Life:  
7 years

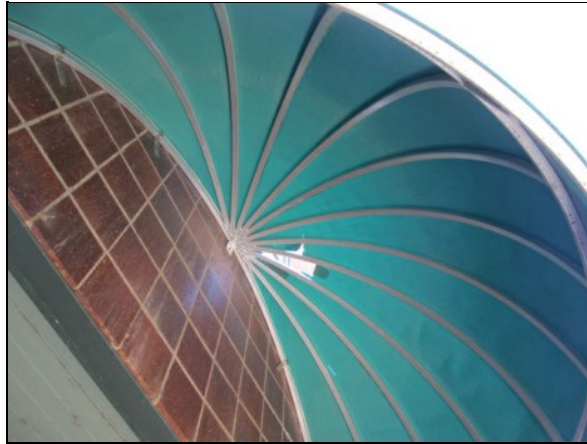
Useful Life:  
20 years

Remaining Life:  
0 years

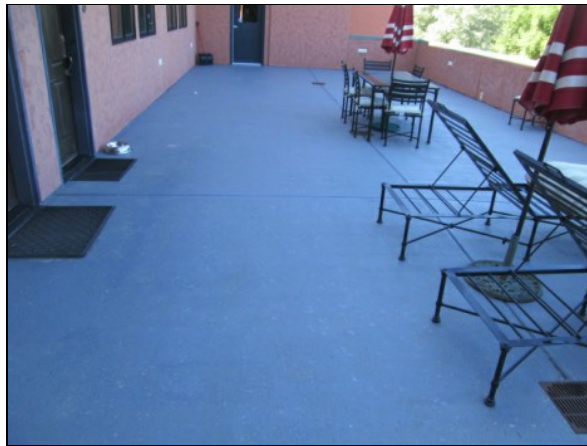
Useful Life:  
10 years

Remaining Life:  
0 years

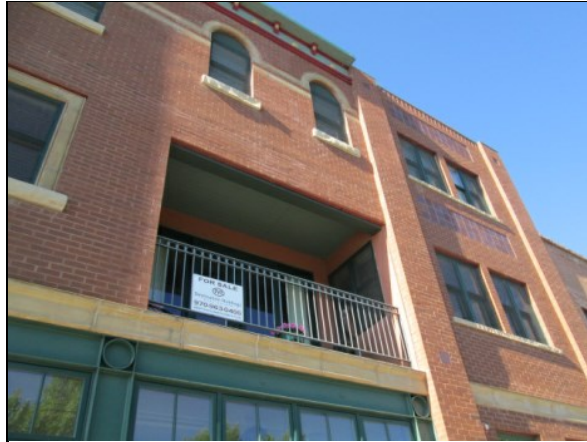
Useful Life:  
5 years

Remaining Life:  
0 years

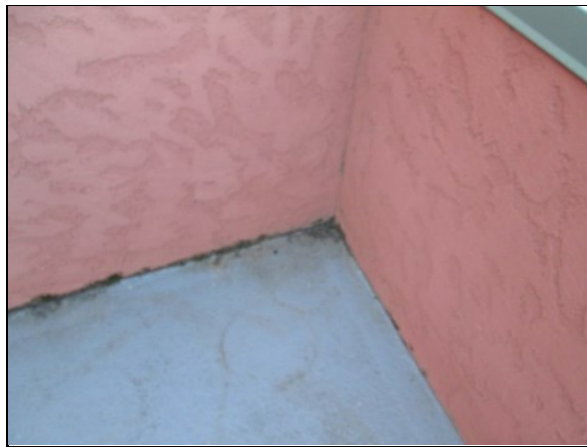
Useful Life:  
3 years

Remaining Life:  
2 years

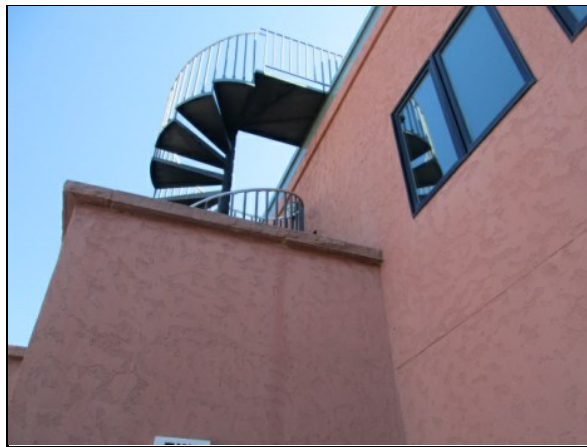
Useful Life:  
2 years

Remaining Life:  
0 years

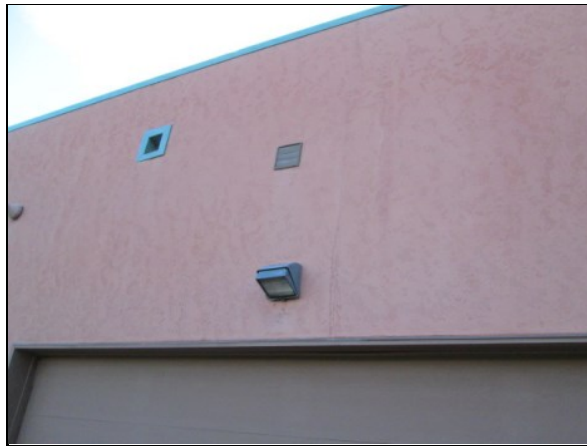
Useful Life:  
15 years

Remaining Life:  
2 years

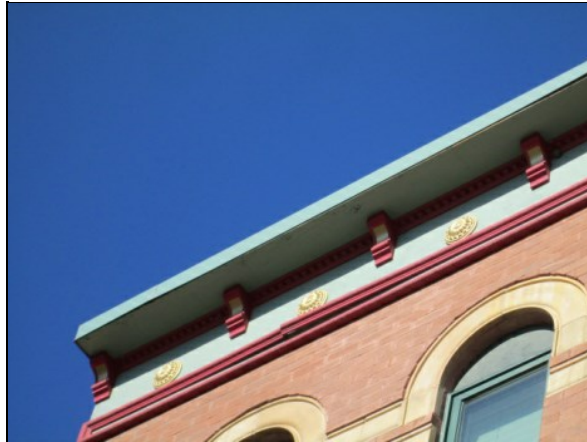
Useful Life:  
7 years

Remaining Life:  
2 years

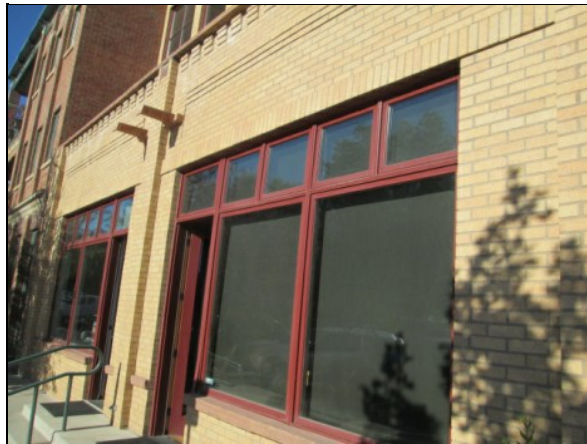
Useful Life:  
30 years

Remaining Life:  
17 years

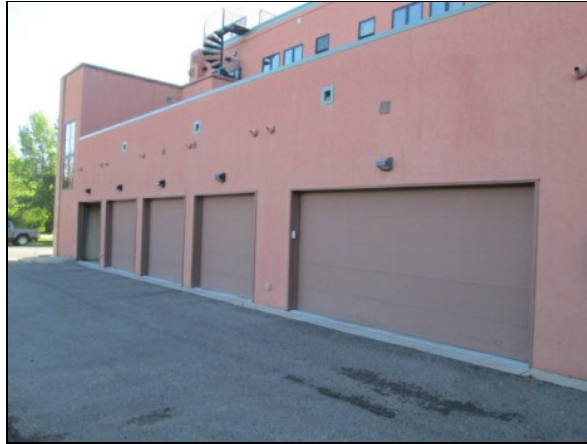
Useful Life:  
10 years

Remaining Life:  
0 years

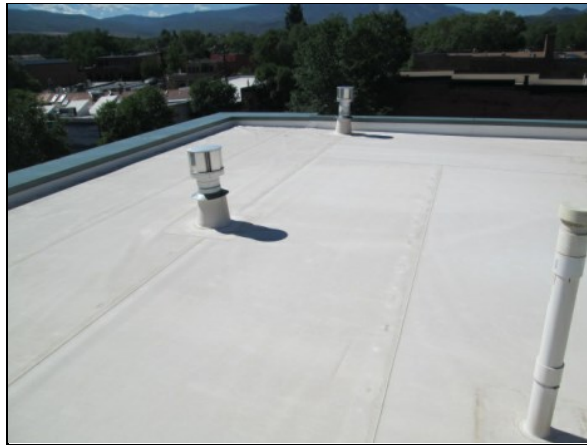
Useful Life:  
20 years

Remaining Life:  
7 years

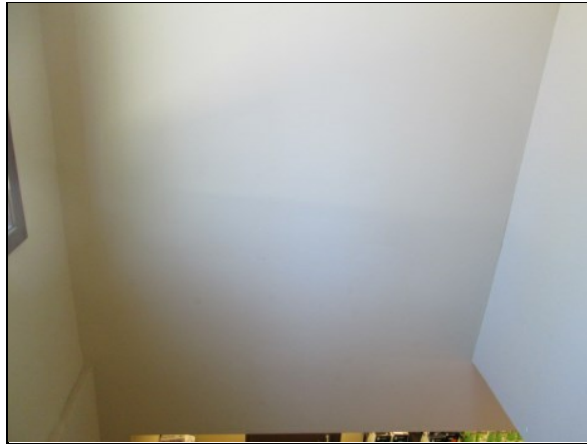
Useful Life:  
10 years

Remaining Life:  
0 years

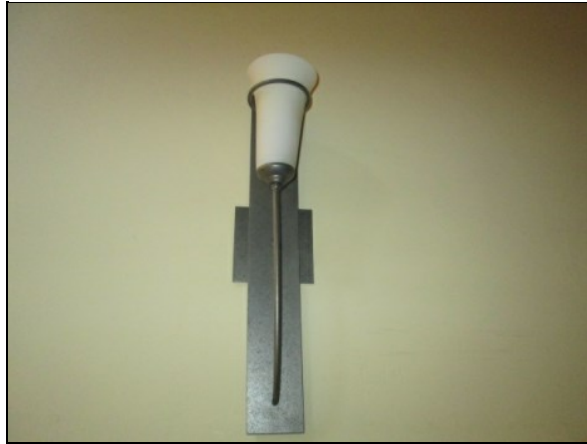
Useful Life:  
25 years

Remaining Life:  
12 years

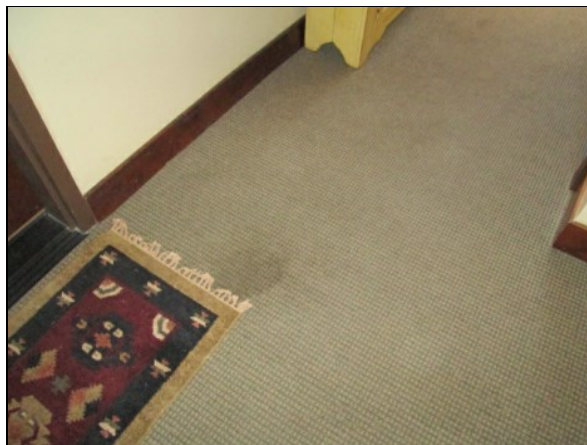
Useful Life:  
10 years

Remaining Life:  
0 years

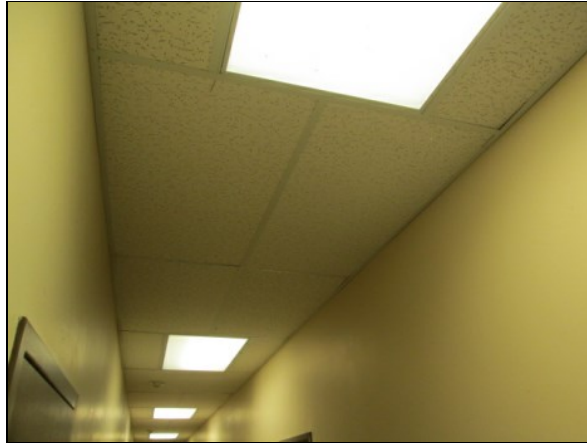
Useful Life:  
30 years

Remaining Life:  
17 years

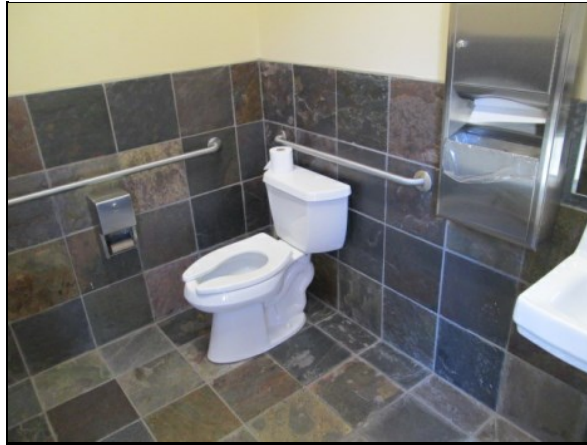
Useful Life:  
25 years

Remaining Life:  
12 years

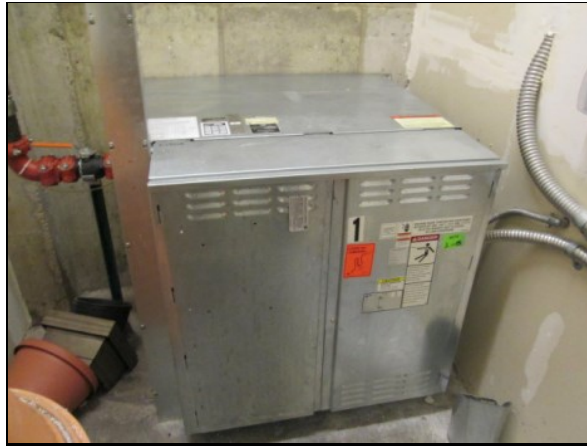
Useful Life:  
25 years

Remaining Life:  
12 years

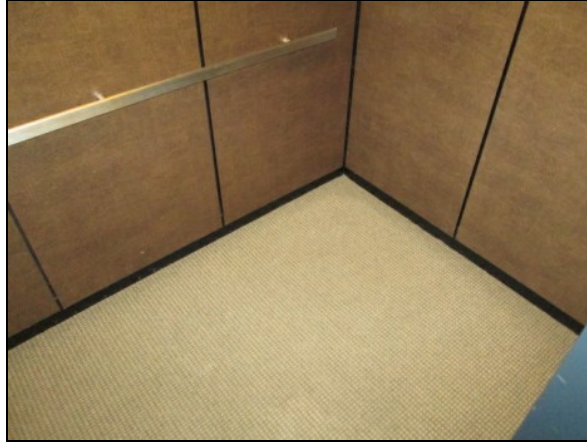
Useful Life:  
25 years

Remaining Life:  
12 years

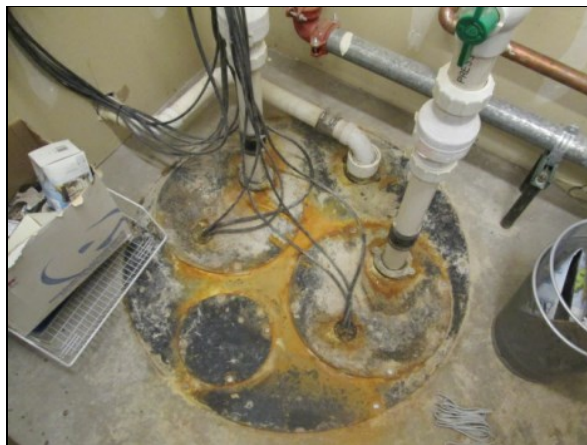
Useful Life:  
10 years

Remaining Life:  
0 years

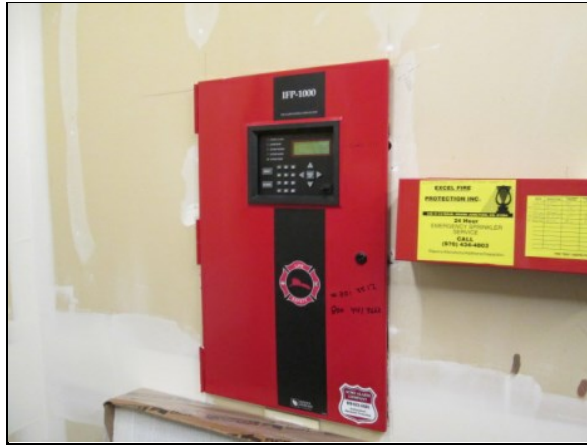
Useful Life:  
20 years

Remaining Life:  
7 years

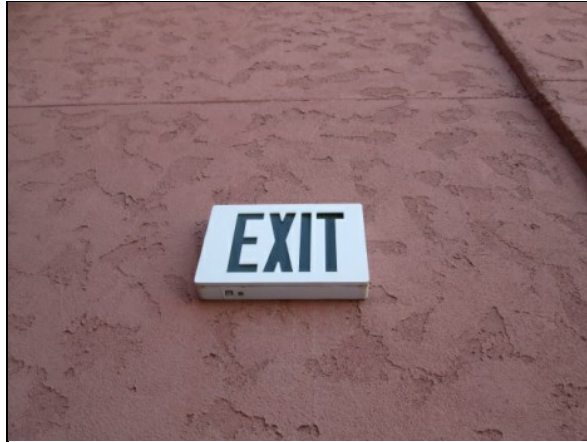
Useful Life:  
25 years

Remaining Life:  
12 years

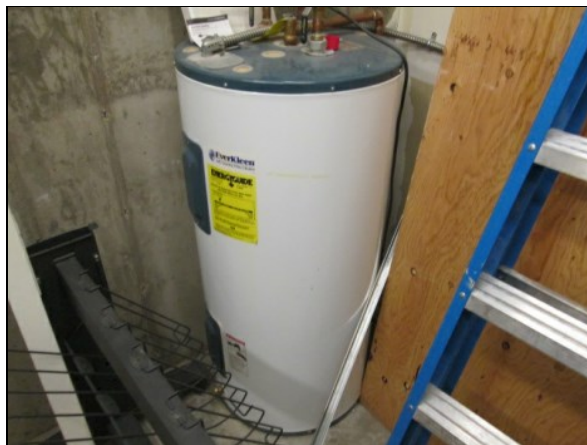
Useful Life:  
15 years

Remaining Life:  
2 years
