Panorama Ranches Homeowners Association
Water System Manual
June 2021

Introduction & Purpose

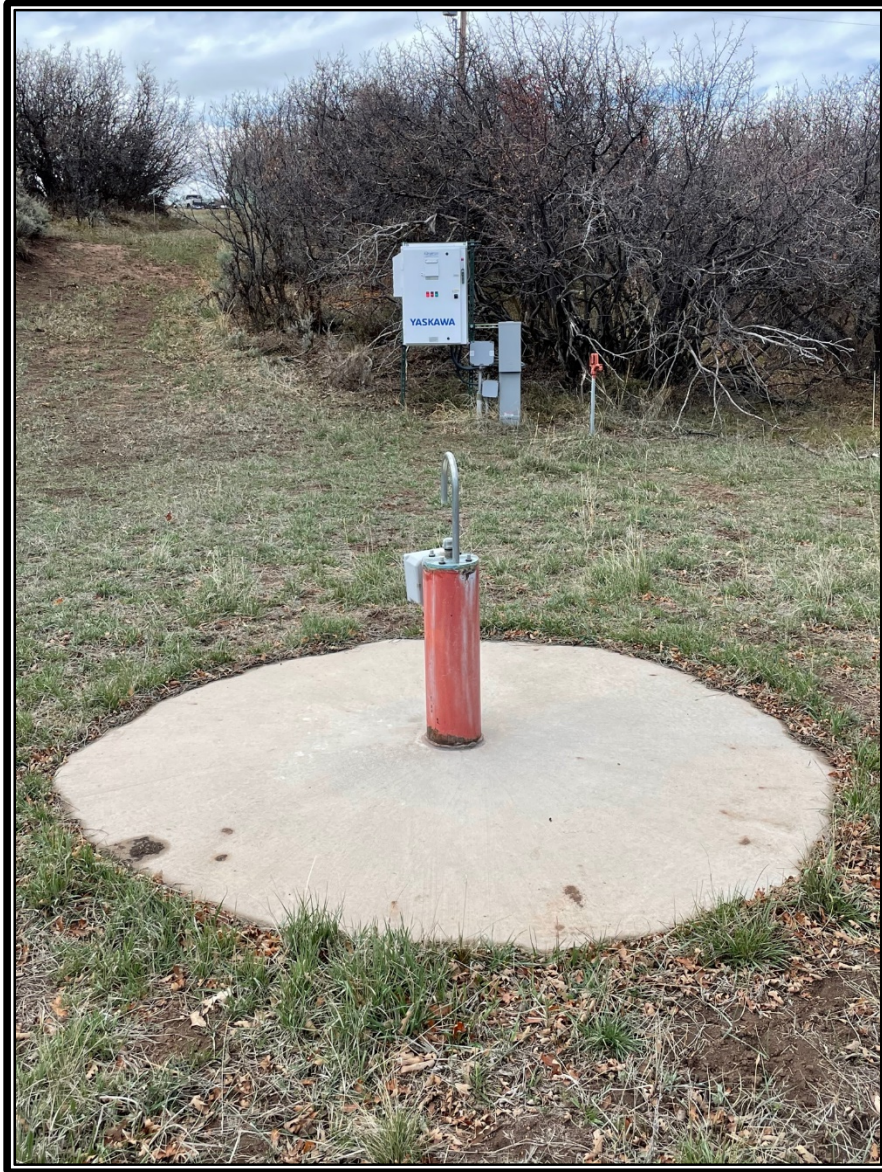
Well No. 1-R, VFD and Electrical Controls on Homestead 21

Well No. 1-R located on Homestead 21 pumps water through a dedicated 2” PVC line on the south side of and paralleling Basalt Mt. Drive to pump house. Well #2 located in the pump house on Homestead 24 and delivers water through a 2” galvanized line. Water from both wells enters the well house where it is chlorinated, metered and then combined in a 2” galvanized line. After the water combines, it flows through a 12” serpentine pipe system to achieve required chlorine contact time. Water from the serpentine pipe outlet

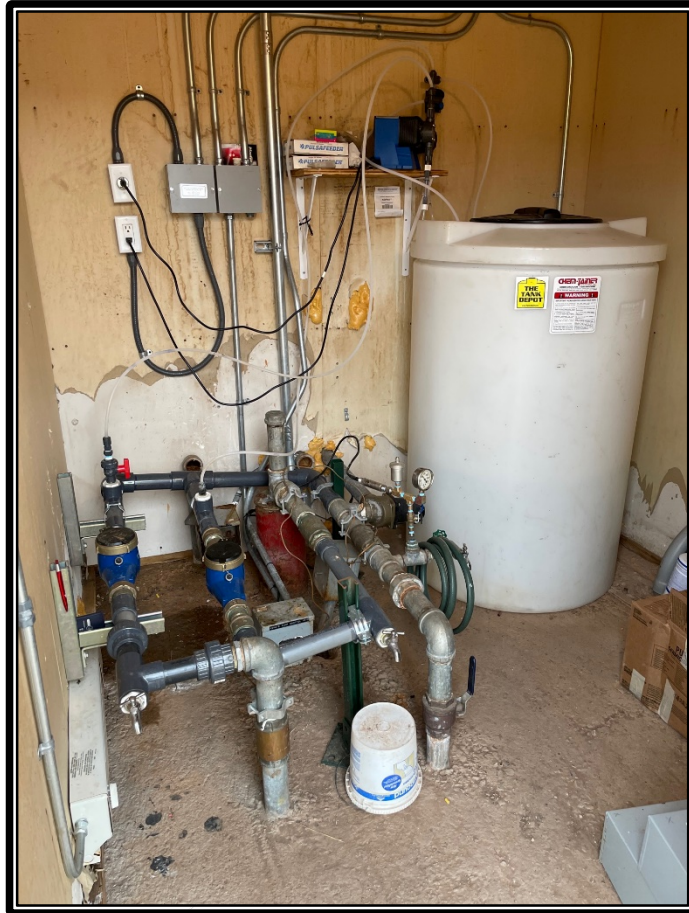
View of Well 1R, Meters and 2" Pipe Manifolds in Pump House 1

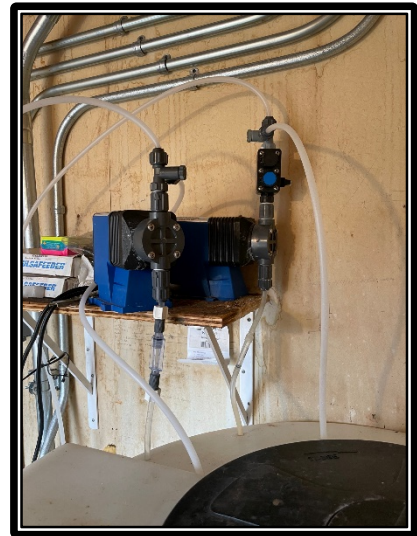
Sodium Hypochlorite Injection Pumps

Water disinfection is provided through injection of diluted sodium hypochlorite (liquid bleach) from a 100-gallon storage tank in the pump house. Sodium hypochlorite is injected by a metering pump in the manifold into each well inlet line just before the two sources combine in the pump house. The chlorinated water is delivered to a 12" C900 DR-18 serpentine pipe system. There are three 45 ft long runs, with an individual length to diameter ratio (L/D) of 45, and overall L/D of 110. This design results in a baffling factor (BF) of 0.7 in accordance with CDPHE Baffling Factor Guidance Manual. For more detailed information see the posted 2019 Basis of Design Report (BDR). Water discharges to the distribution system and storage tank, which is comprised of 6" plastic pipe. There is not a dedicated delivery pipe from the serpentine system to the main storage tank.

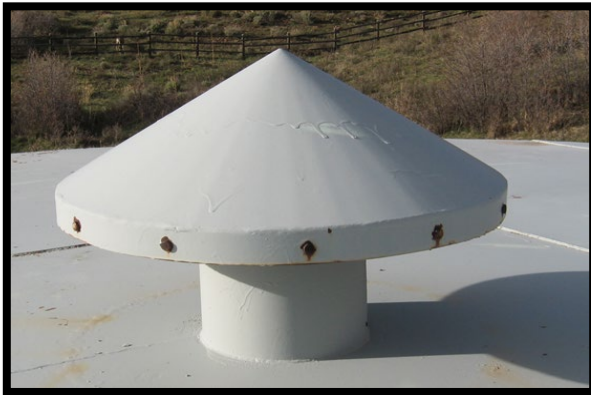
Water Tank Vent & Image of Screen on Underside

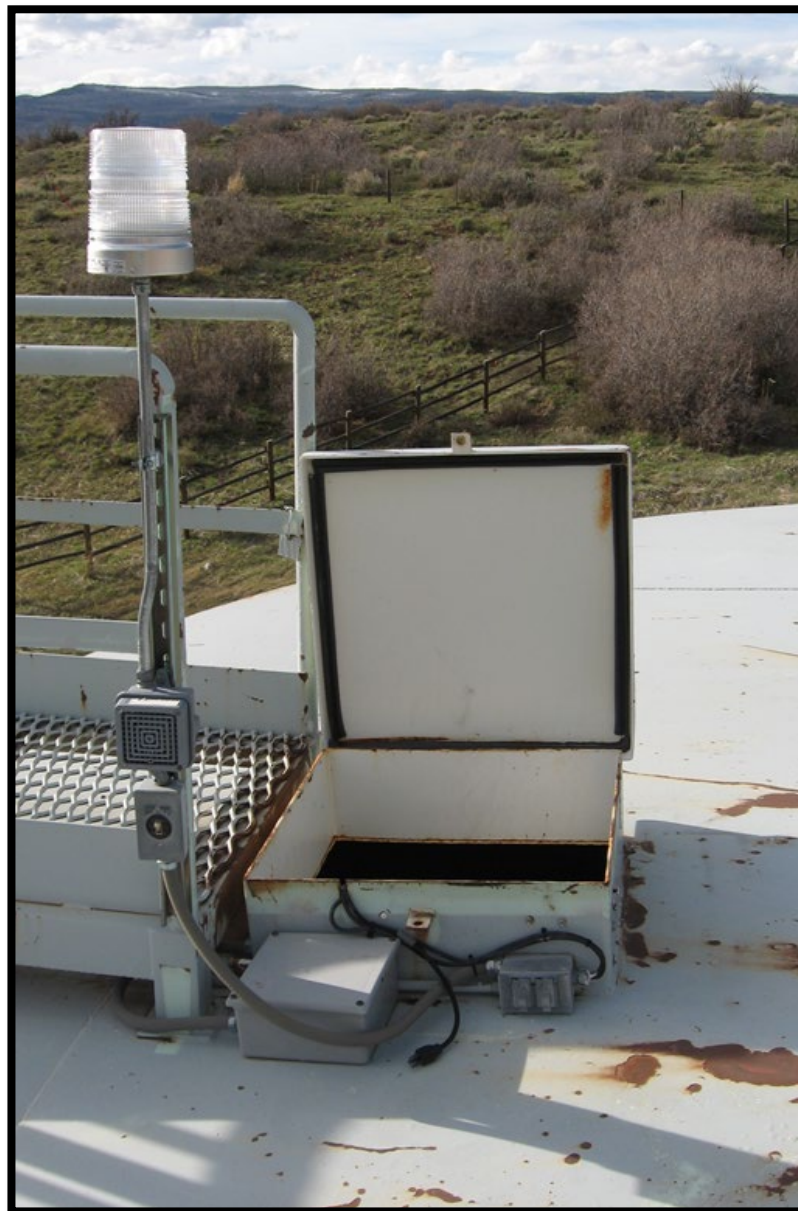
Water Tank Hatch with Seal, Warning Strobe & Warning Buzzer

The tank has a low and high-water level warning strobe light and buzzer alarm that sounds when the tank level falls approximately 3' below the maximum fill level. The tank has an overflow pipe that functions in the event that the tank overfills. In-tank controls consist of several transducer pressure switches that turn the Basalt Mt. Drive high lift pump on and off and also activate the low/high tank level warning strobe and horn. A bolted cover at the tank bottom provides secondary access for tank maintenance. This cover can only be removed when the tank is empty.

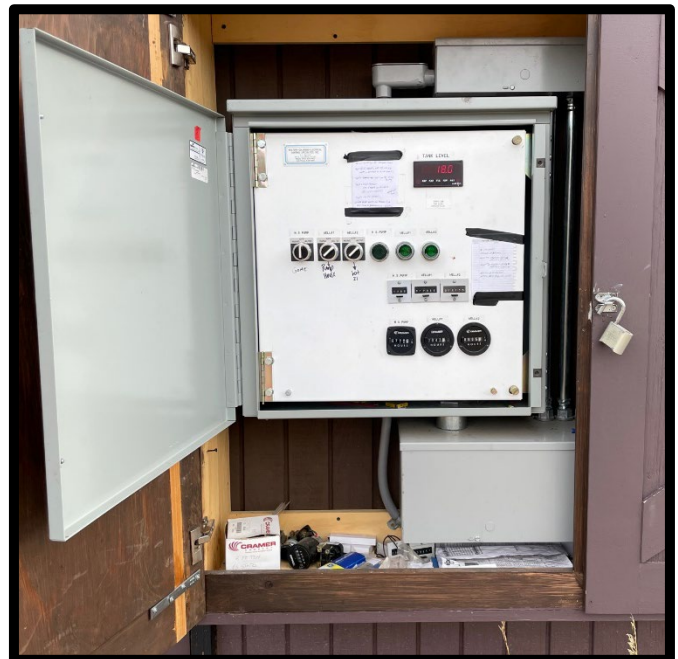
Electrical controls consist of a breaker panel and well pump switches for Well 1-R and Well 2. An operation indicator light is located under each well switch. The panel includes a cycle and hour meter for each of the two pumps, Well 1R and Well 2. Each pump is controlled by a VFD and is set at a specified speed to ramp up to pump 25 gpm from each well simultaneously. An inline pressure transducer located at the well house communicates to the pumps to turn on at a specified distribution system pressure. The pumps are wired to turn on at a pressure that

corresponds to an actual tank level of 18 ft, and turn off at 21.3 ft. The low-level alarm is set to 14 ft, and high-level alarm is set to 21.5 ft.

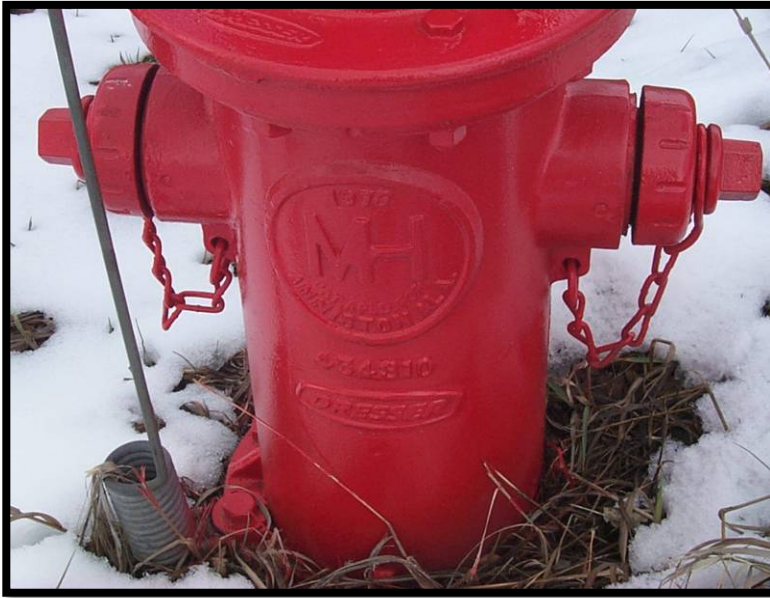
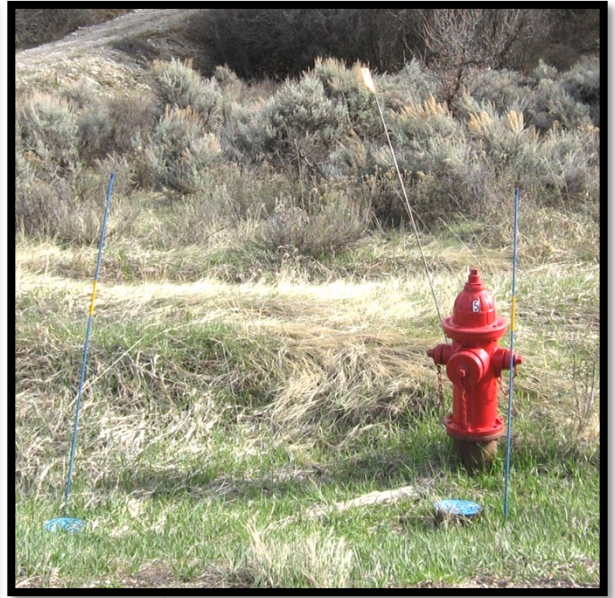
Breaker Box, VFD & Controls for Well 1-R and Hydrant for Raw Water Test Samples from Well

Fire hydrants are flushed and exercised once per year to ensure proper operation and to clean the hydrant barrels. Each fire hydrant has a nearby shutoff valve so that the hydrant can be isolated from the system for replacement or repair. Each hydrant in the system is numbered with a total of 11 Dresser fire hydrants on the main water system. The hydrants in the system are pressurized by the elevation difference of the water tank above each hydrant. Individual hydrant pressures are shown on map of the distribution system in the CDPHE Monitoring Plan. One additional hydrant (Hydrant 12) has been installed adjacent to the water tank on the hill. This is a low-pressure hydrant because it is located at the same base elevation as the water tank and does not meet the pressure or flow requirements of the National Fire Protection Association (NFPA). It can be used as an emergency source of the fire protection water.

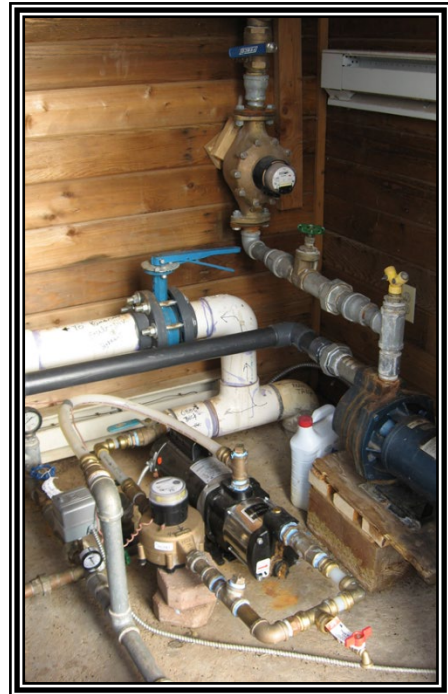
Pump House near Water Tank & Interior Piping.

A second pump house that serves the four Homesteads (53 A, 53 B, 53 C & 53 D) in the Panorama Ranches Minor Subdivision Exemption is located on the top of the hill in general proximity to the water tank. The pump house building and the water lines serving the previously mentioned Homesteads are owned and maintained by the Panorama Ranches Homeowners Association. The electronic controls, pumps, pressure tanks and other equipment in the pump house are the responsibility of one or more of the homeowners of the aforementioned Homesteads. In addition, a low-pressure fire hydrant was installed by the owners of Homestead 53C and operations/maintenance of that hydrant are the responsibility of that homestead owner.
